REMR Bulletin

Volume 13, Number 2

May 1996

Seismic Strengthening of Hotel Oakland Revisited: A Case Study

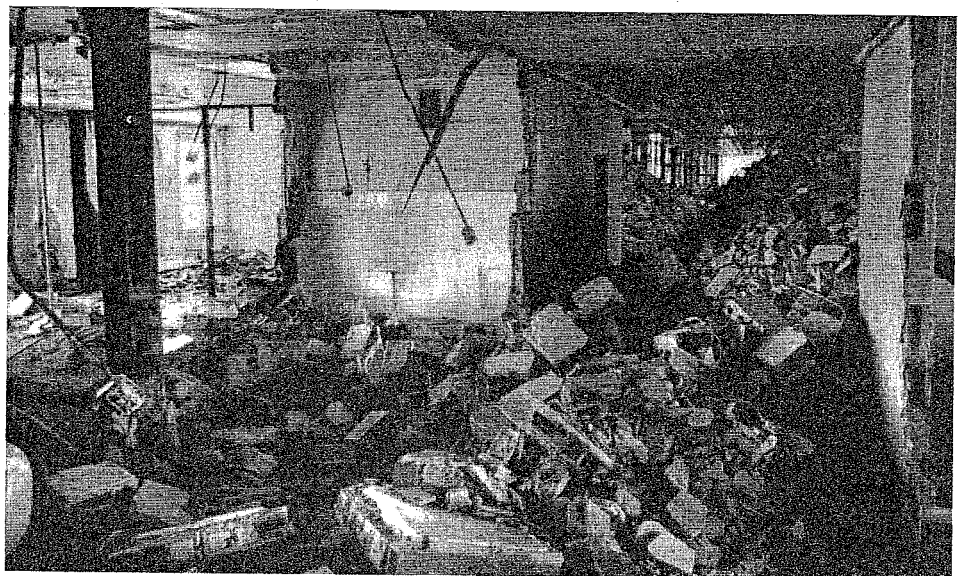
Figure 2. Clay tile partition rubble from 1979 renovations

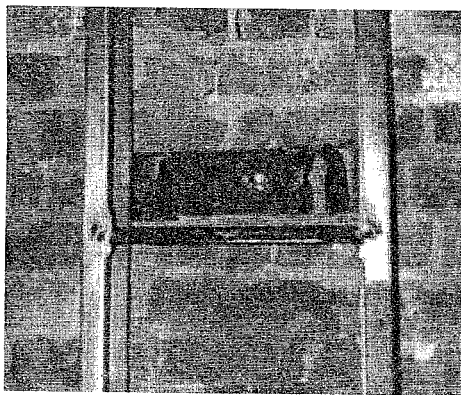
Figure 3. Structural studs and wall anchor

The system devised was incorporated into the new wall furring that was applied within the steel frames of the exterior walls (Figures 3 and 4). Heavier structural studs were mixed in with the basic stud-furring system and were spaced so that wall anchors could be secured on approximately 3-ft centers in both vertical and horizontal directions. The wall anchors were 1/2-in.-diam bolts that were long enough to extend from the structural studs through the two interior wythes of the exterior wall and into the face brick. The bolts were inserted into the wall through holes drilled into the brick to a depth including partial penetration in the face brick. They were then anchored to the brick with polyester-resin epoxy cartridges.

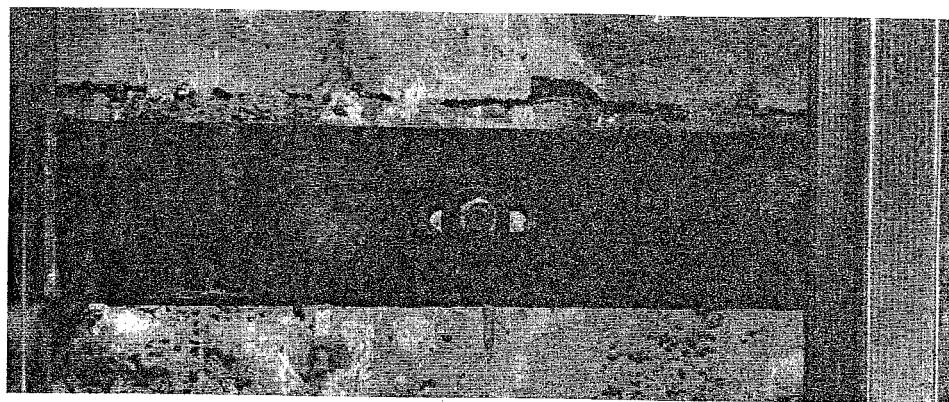
Figure 4. Detail of basketing anchor

To complete the wall anchorage, the bolts were attached to plates that spanned adjacent structural studs. The stud system then provided a positive anchorage detail to the floor framing above and below. Thus, the exterior wall system was reinforced with steel studs having the capacity to brace the walls against out-of-plane forces after failure of the brick. The system was intended to hold the brick in place, reduce potential falling hazard, and use the crushing of the brick during an earthquake for its energy-absorbing value.

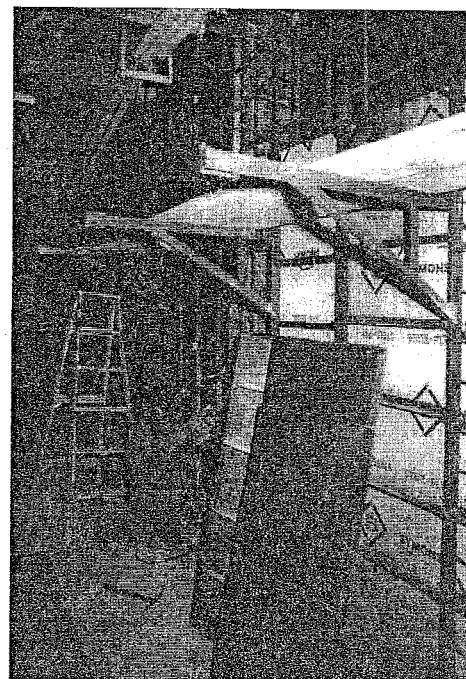
Figure 5. Forming for interior shear walls

Reinforcement of the exterior brick walls was important to the performance of the building in an earthquake, but it was only part of the story. To provide additional strength and ductility to resist major earthquakes, a new system of reinforced-concrete shear walls was designed to be added around the stair and elevator shafts (Figure 5). This system was well distributed around the building in the upper stories and was supplemented by additional shear walls from the second floor down to the foundations.

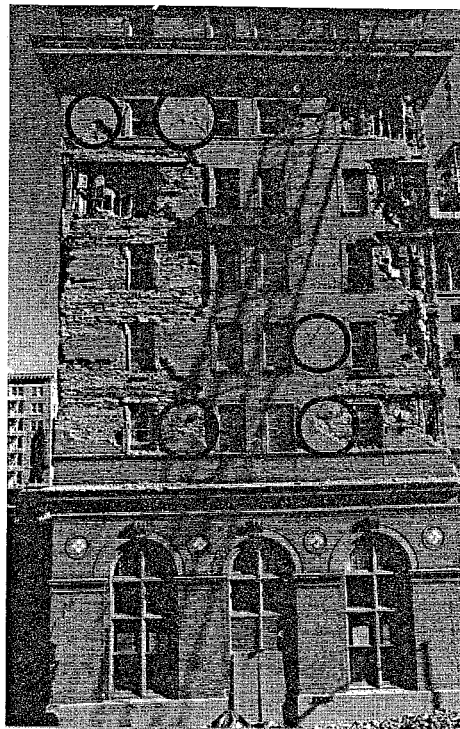
The most significant damage sustained by the hotel was cracking of some of the exterior brick walls. Although not load-bearing, these brick walls were the stiffest elements in the building, and they resisted the main thrust of the earthquake force. The damage was manifested as diagonal (X) cracks in the wall piers with virtually no cracking in the horizontal spandrels (Figure 6).

In the most severely damaged wing, the cracks were over 1/2 in. wide, with complex fracturing through the entire thickness of this wall. There were also areas where the face brick had fallen and other areas where it was loose. The damage in this area was enough to create a potential life-safety hazard that could not be ignored. An aftershock could dislodge portions of the wall that could fall on people below. It appeared that the brick in this area would have to be removed and replaced.

Figure 6. Damage to southwest facade after removal of loose brick

The exterior brick walls required significant work to repair the cracks caused by the earthquake. The cracks were injected with epoxy to restore original strength, and the finish was then patched to match the adjacent surfaces as closely as possible. The restoration process was complicated by the effects of cleaning on the existing material and on the new face brick and mortar.

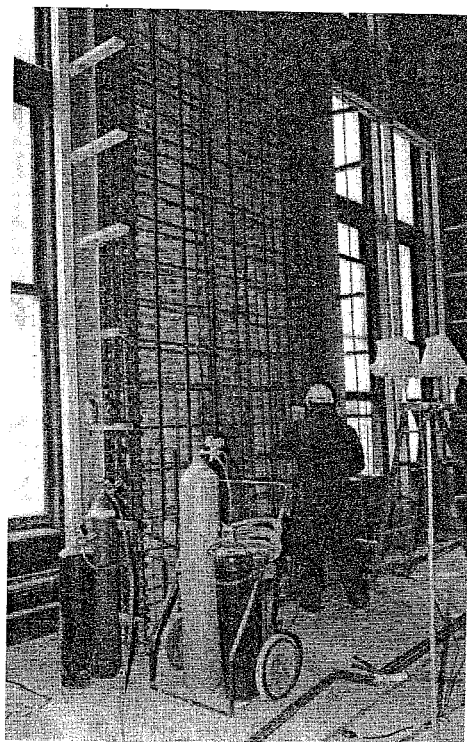
Figure 7. Strengthening of walls behind historical facades

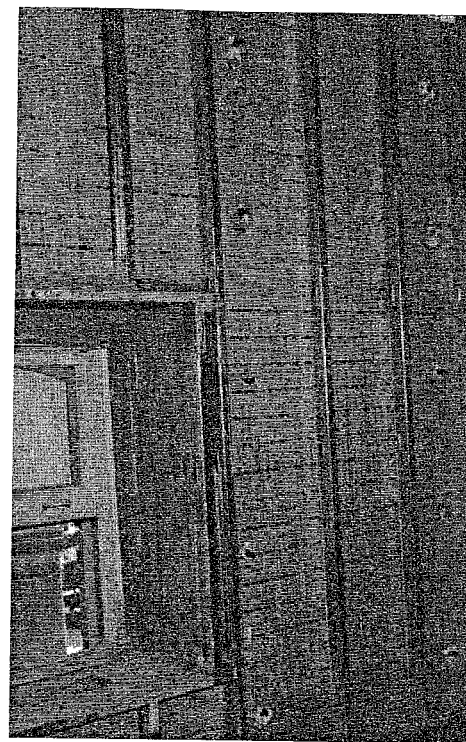
Figure 8. Strengthening of typical upper floor walls
